IDAHo DEPARTMENT OF ENVIRONMENTAL QUALITY AND THE COCOLALLA
LAKE ASSOCIATION

Cocolalla Lake TMDL 5-Year Review

Summary from Pend Oreille Lake and Pend
Oreille River Tributaries TMDL 5-Year Review

Review of Cocolalla Lake watershed characteristics, Citizens Volunteer Monitoring data report, bathymetric characterization, implementation projects completed, educational programs ongoing, road crossing assessment, geomorphic risk sediment source assessment, and periphyton assessment.

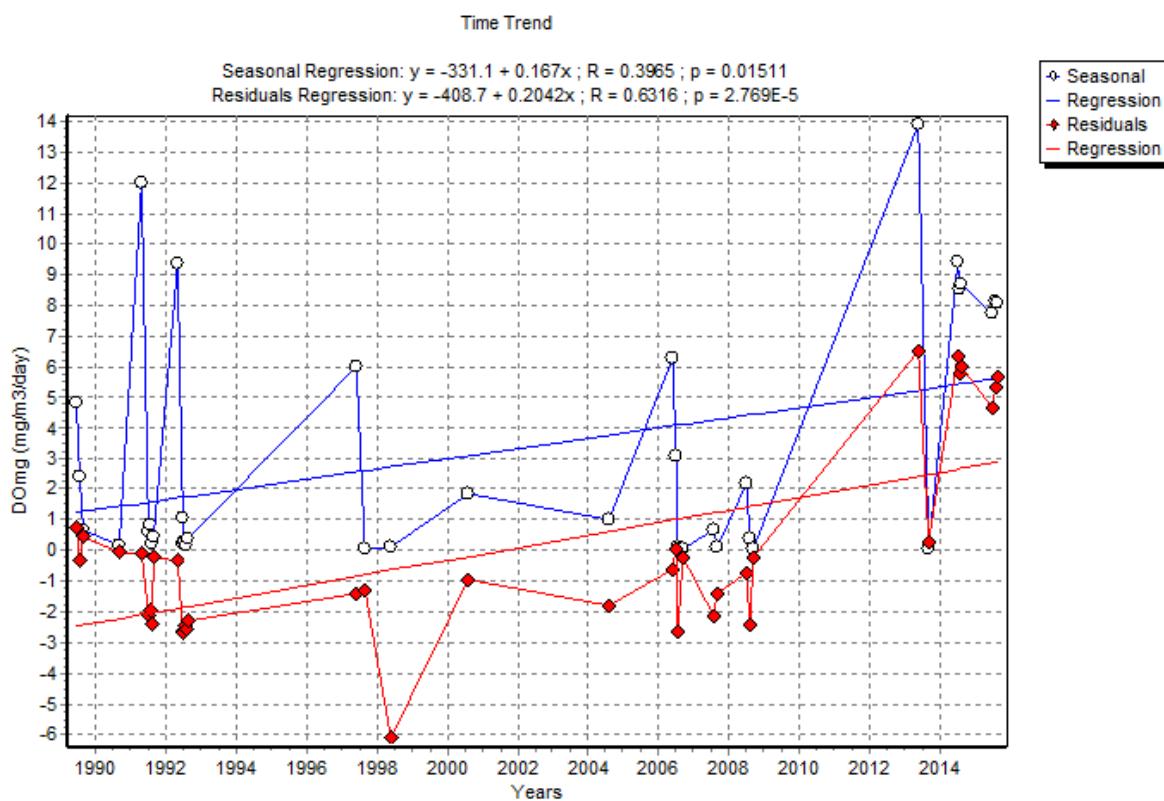
An evaluation of DO trend data in Cocolalla Lake shows that in recent years, incidents of hypolimnetic anoxia and hypoxia are less frequent and shorter than in previous years. Anoxic hypolimnion conditions in Cocolalla Lake seem to manifest during periods of warm weather, bright sunlight, and reduced wind for mixing and circulation. These conditions often precede conditions that facilitate blue-green algae blooms. The lake oxygenates during occasional wind events that mix waters over all but the deepest areas of the lake. DO is plotted from 1989 to present with time trend data showing improvement in hypolimnetic DO. Data represented are based on seasonal data and associated residuals to show overall improving trends (**Figure 3**).

Figure 3. Hypolimnion dissolved oxygen regressions for data from 1989 through the 2015 field season.

DO data in Cocolalla Lake show that epilimnetic DO generally stays above 6 mg/L throughout the summer months and is not stressful to fish. In recent years, incidents of hypolimnetic anoxia and hypoxia are less frequent and shorter duration than in previous years. Aggressive aquatic nuisance species management by the Cocolalla Lake Association has reduced DO demand by reducing biomass and plant decay.

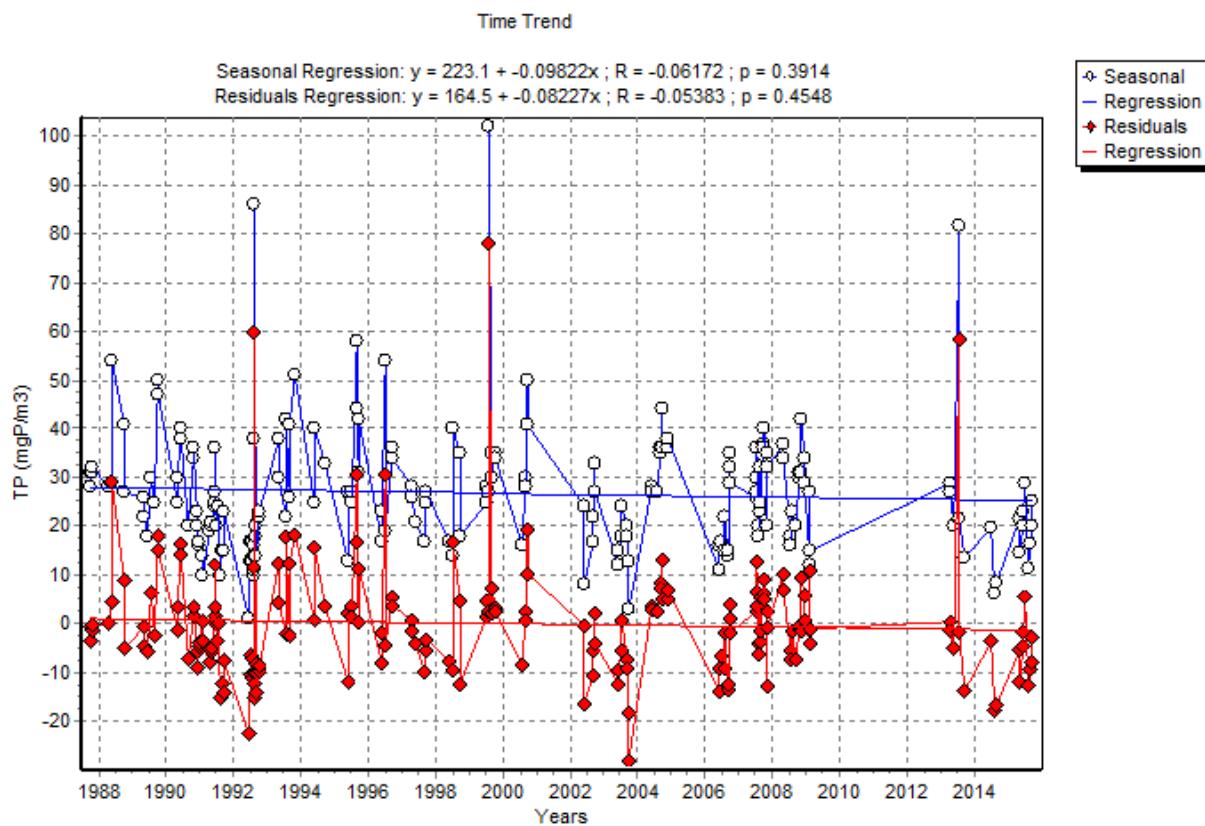
Data throughout the evaluation period show slight improvement of epilimnion total phosphorus, although wind mixing can periodically break down stratification and increase variability of total phosphorus concentrations. Regression of seasonal and associated residuals shows phosphorus concentrations may be decreasing slightly though the trend indicator for calculation with residuals is more static though lower values. Epilimnion total phosphorus over time is shown in **Figure 4**.

Figure 4. Epilimnion total phosphorus regressions for data from 1988 through the 2015 field season.

Water quality and trophic state is improving in Cocolalla Lake. Water quality data shows slight improvement of water clarity and improvement of epilimnetic total phosphorus concentrations. More recent epilimnetic total phosphorus concentrations have generally been observed in a range of <10 µg/L to 30 µg/L. However, wind mixing can periodically break down stratification and increase the variability of total phosphorus concentrations. Nevertheless, total phosphorus concentrations are still above the TMDL target, and nutrient loads to Cocolalla Lake still need to be reduced.

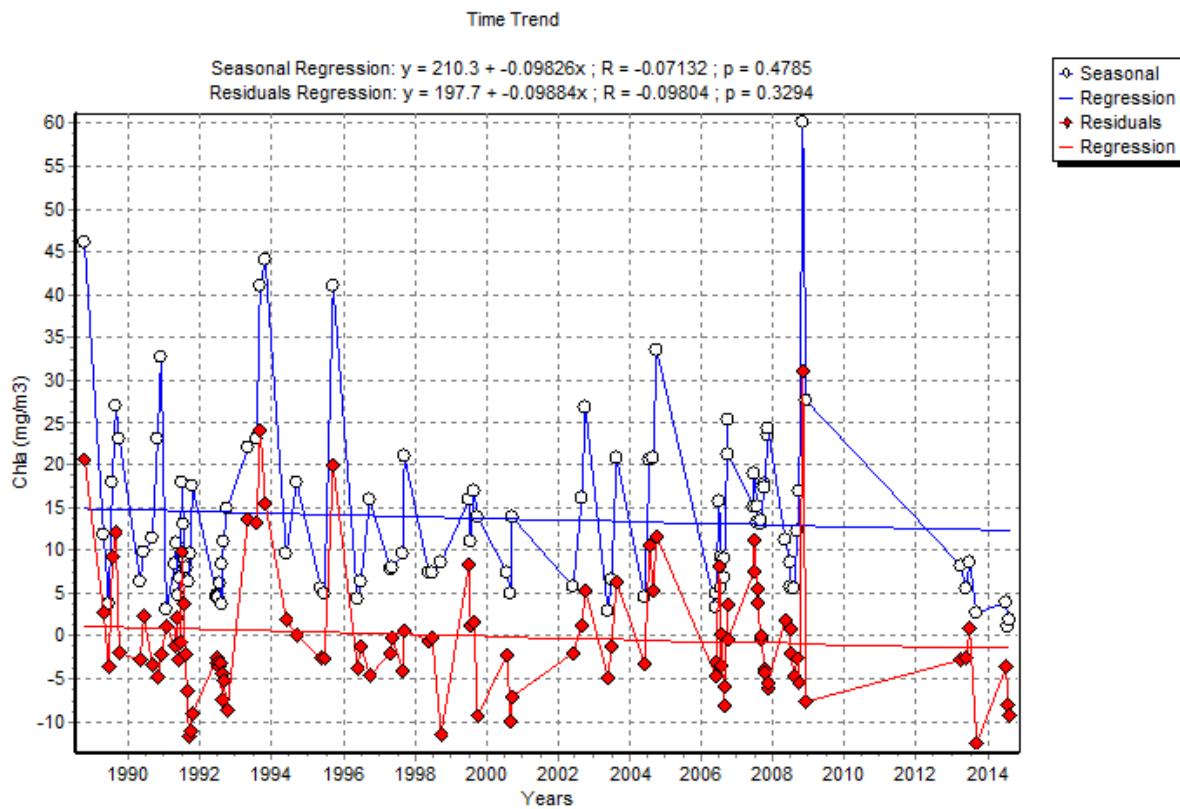
Trophic State Index calculations are based on Secchi disk depth as well as nutrient and chlorophyll-a data. While the long-term trend analysis does not show a significant decrease in chlorophyll-a since 1987, chlorophyll-a concentrations do seem to be lower in the last 3 years (**Figure 5**). The long-term trend data show increasing water clarity as evidenced by increasing Secchi depth readings (**Figure 6**).

Figure 5. Chlorophyll-a regressions for data from 1988 through the 2015 field season.

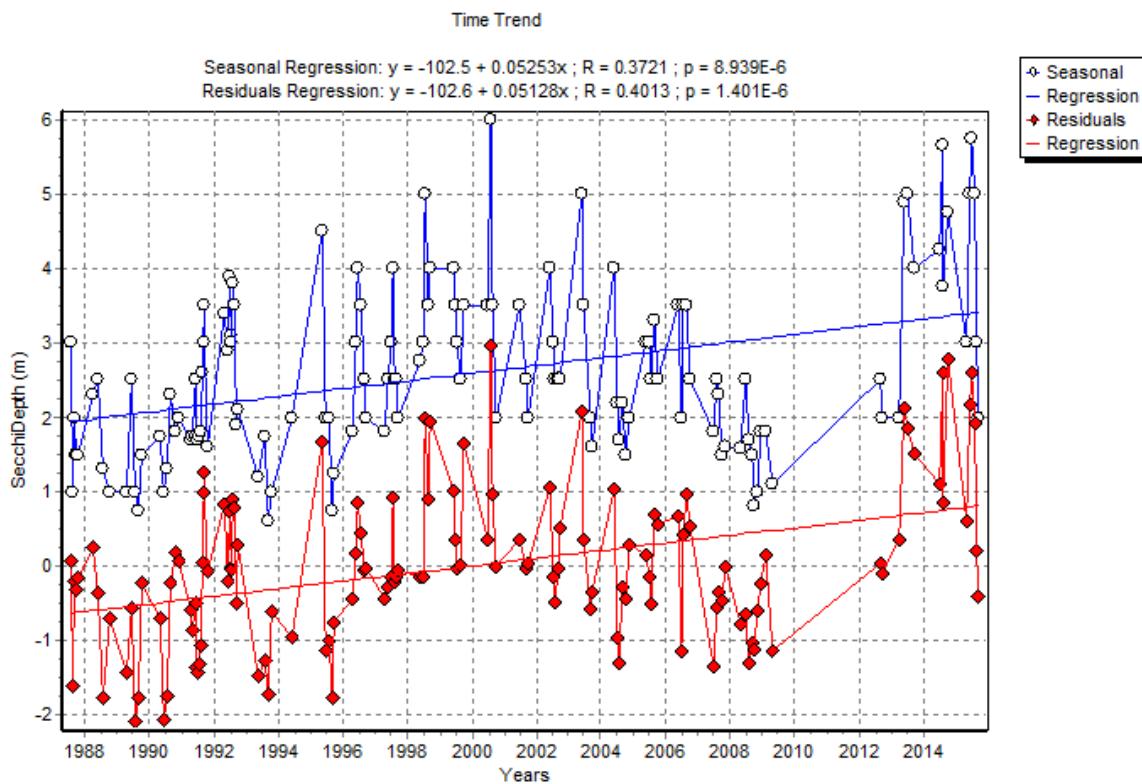
Figure 6. Secchi depth regressions for data from 1988 through the 2015 field season.

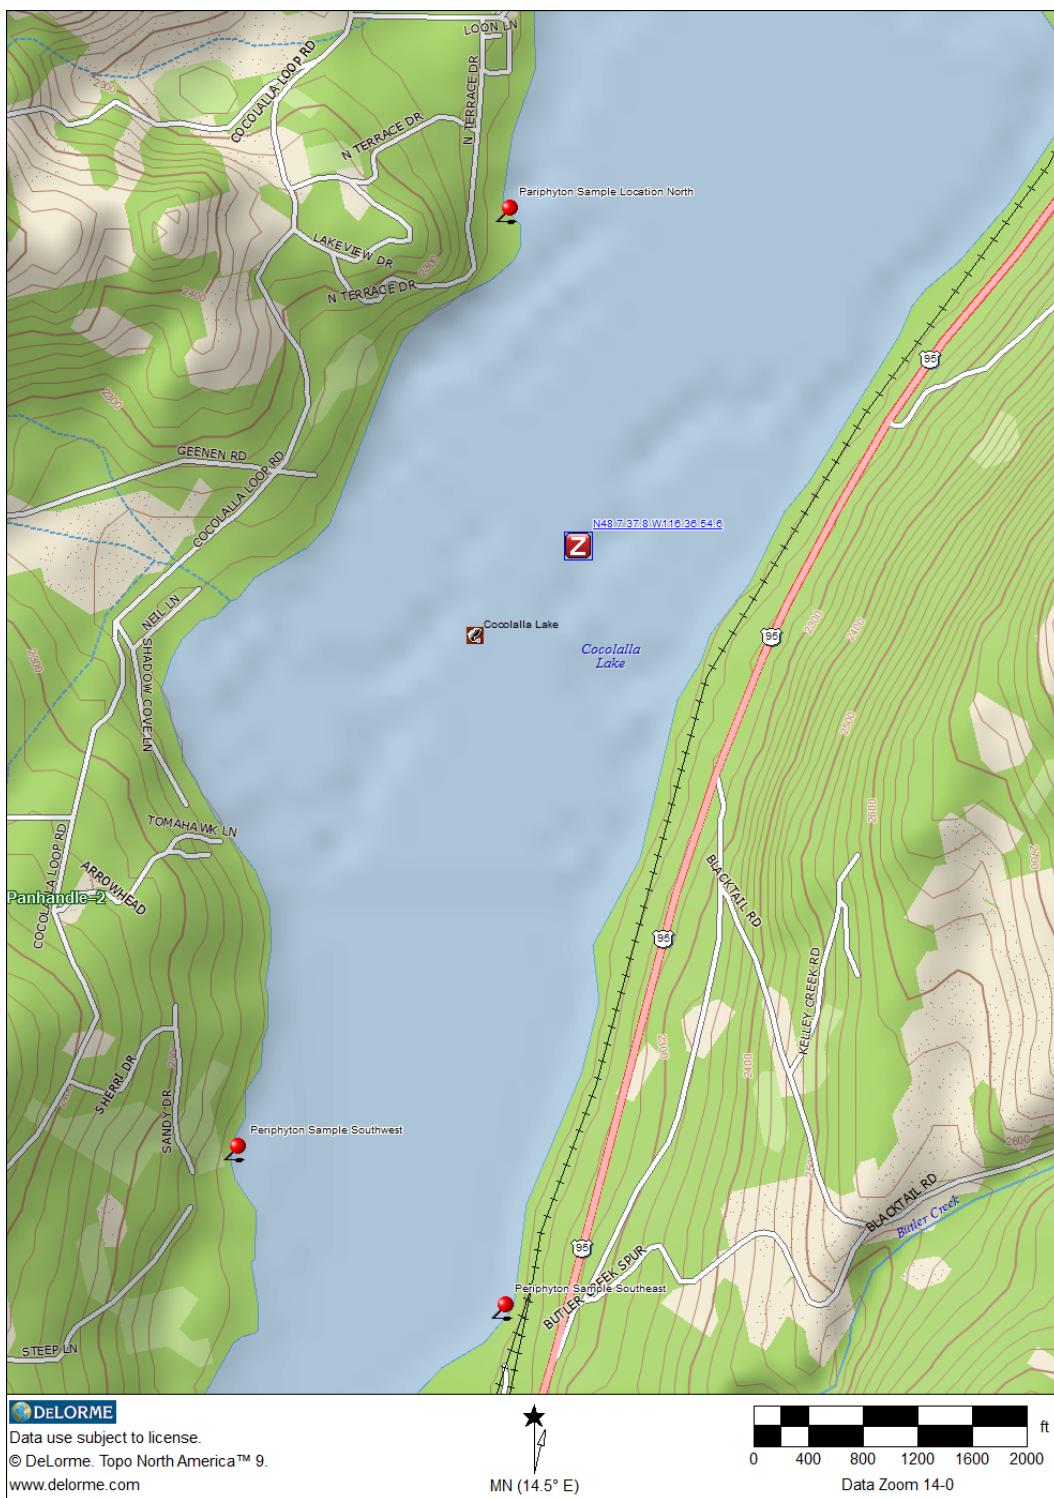
Artificial substrates were deployed at three nearshore locations during the week of August 9, 2015, and were visited weekly for the following 6 weeks (**Table 1, Figure 7**). The substrates were retrieved the first week of October. Periphyton samples were collected and analyzed for chlorophyll-a concentrations each week. Analysis of chlorophyll-a in the periphyton was used to determine a growth rate and a relative measure of productivity. During the retrieval, an additional periphyton sample was taken for periphyton taxa identification and enumeration.

Figure 7. Location of 2015 periphyton sampling sites on Cocolalla Lake.

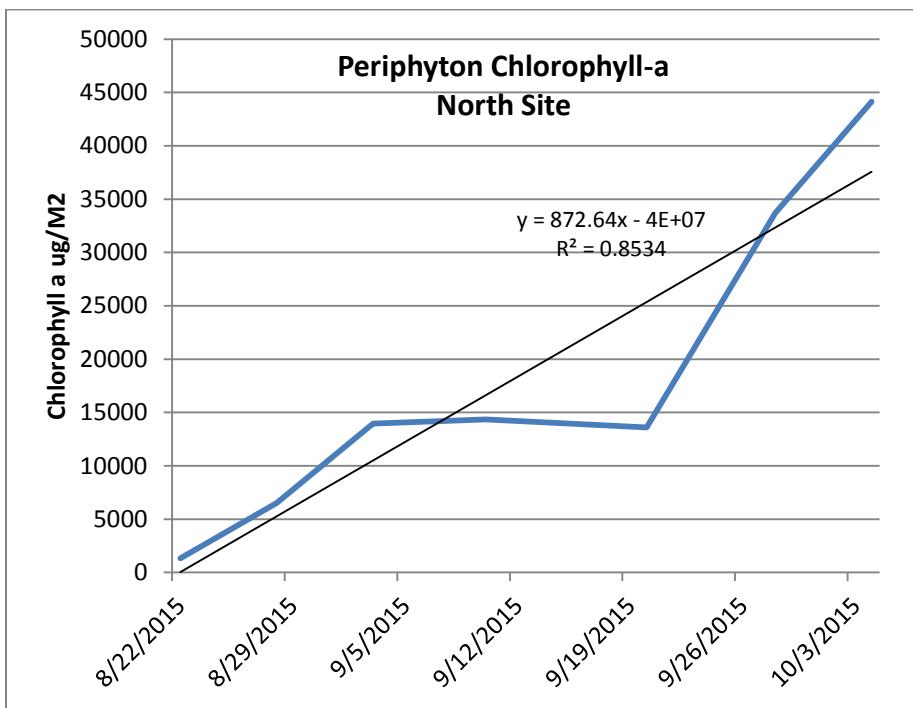
Figure 8 through **Figure 10** illustrates chlorophyll-a growth rates at the three sites. All graphs show good regressions for biologic measures. The study should have run longer to capture a leveling off of the growth rate, where the periphyton is fully stocked and additional growth is limited by space. The average chlorophyll-a growth rate for both the northern and southeastern sites were above 600 $\mu\text{g}/\text{m}^2/\text{day}$. The southwestern site had a lower growth rate of 346 $\mu\text{g}/\text{m}^2/\text{day}$. The southeastern site had a growth rate of 625 $\mu\text{g}/\text{m}^2/\text{day}$. The chlorophyll-a data suggest that water column nutrients in the northern portion of the lake support higher periphyton productivity than do the nutrients in the southern portion of the lake. This higher productivity may be partially due to prevailing winds from the southwest and potential accumulation of nutrients from lakeshore residences. It can also be due to in-lake productivity of localized substrate and accumulation of internal nutrient loading from biological processes.

Figure 8. Periphyton chlorophyll-a growth rate, north site.

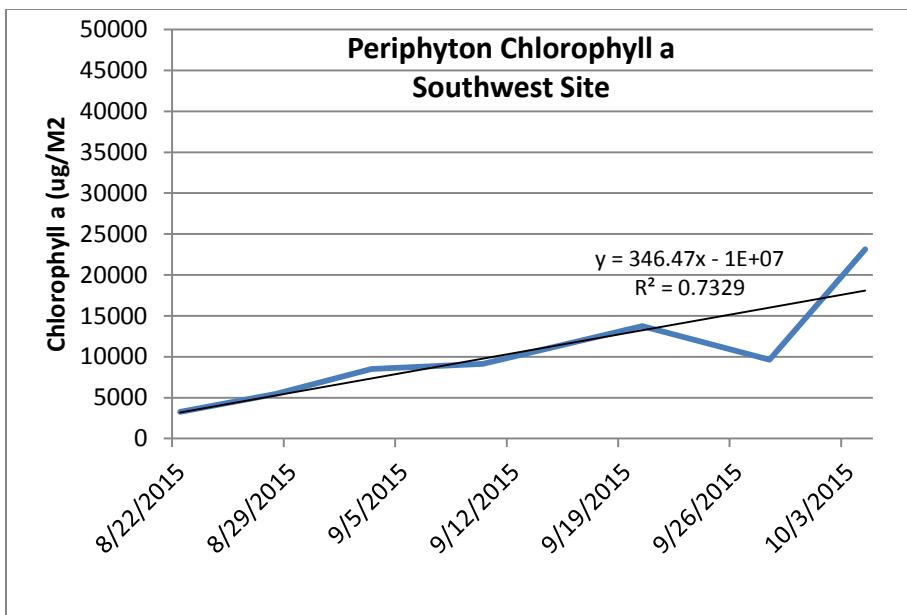
Figure 9. Periphyton chlorophyll-a growth rate, southwest site.

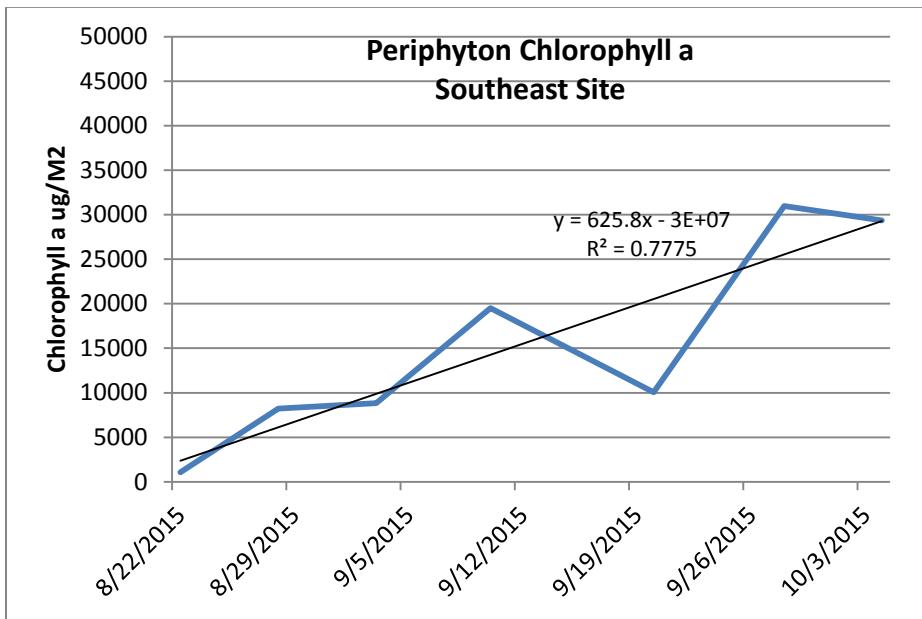
Figure 10. Periphyton chlorophyll-a growth rate, southeast site.

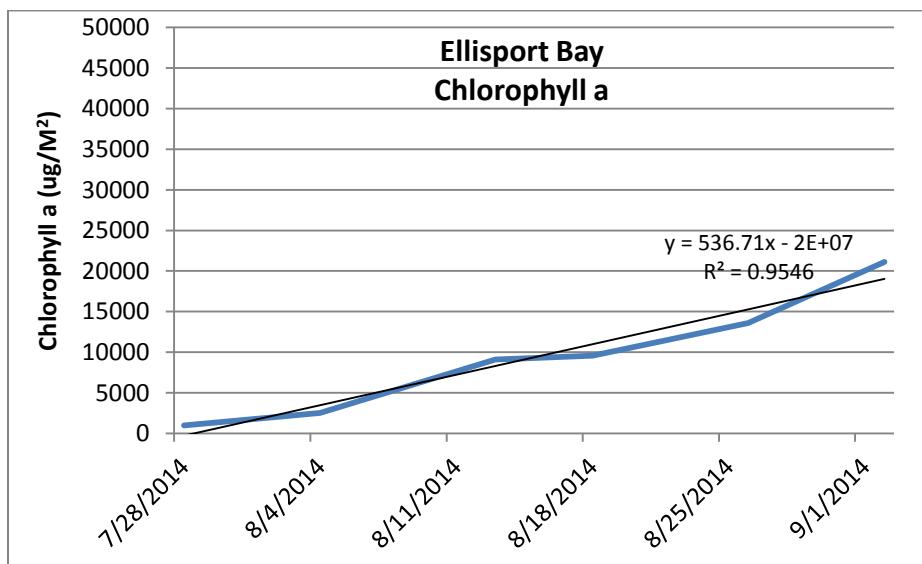
southern portion of the lake (Idelwilde Bay) were chosen for this comparison. Chlorophyll growth rate in Ellisport and Kootenai Bays were approximately $535 \mu\text{g}/\text{m}^2/\text{day}$ (**Figure 11** and **Figure 12**). The chlorophyll growth rate in Idelwilde Bay was $134 \mu\text{g}/\text{m}^2/\text{day}$ (**Figure 13**). Both the northern and southeastern locations on Cocolalla Lake exceeded the rates in the northern bays of Lake Pend Oreille. A comparison of water column concentrations of total phosphorus in Cocolalla Lake and Lake Pend Oreille suggest periphyton productivity in Cocolalla Lake is a result of the higher nutrient concentrations. As stated earlier, epilimnetic total phosphorus in Cocolalla Lake generally ranges between less than $10 \mu\text{g}/\text{L}$ and $60 \mu\text{g}/\text{L}$. However, higher epilimnion values from 60 to $100 \mu\text{g}/\text{L}$ are observed, likely a result of wind mixing events with the higher-concentration hypolimnion. During 2006–2015, mean total phosphorus concentrations in Ellisport, Kootenai, and Idelwilde Bays were all below $8 \mu\text{g}/\text{L}$.

Figure 11. Periphyton chlorophyll-a growth rate, Ellisport Bay, Lake Pend Oreille.

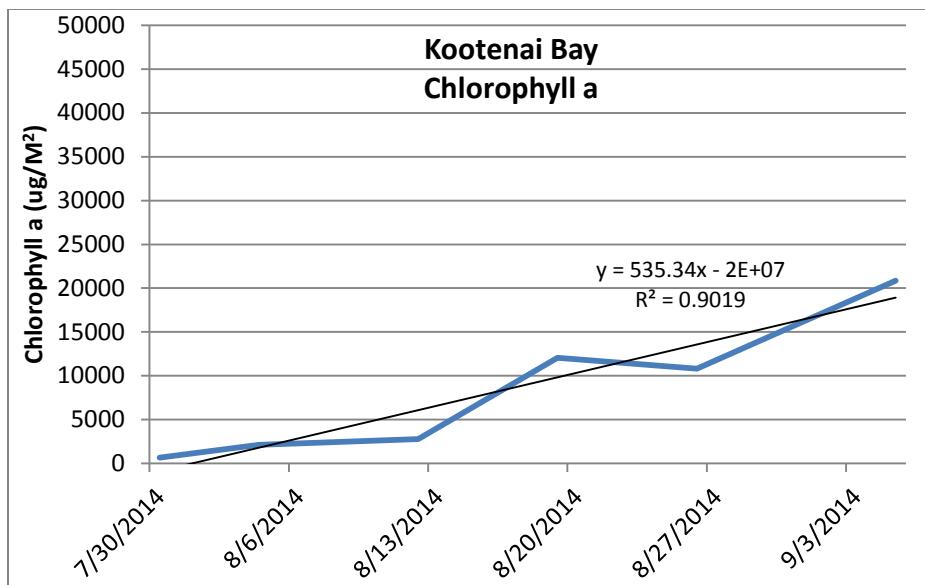
Figure 12. Periphyton chlorophyll-a growth rate, Kootenai Bay, Lake Pend Oreille.

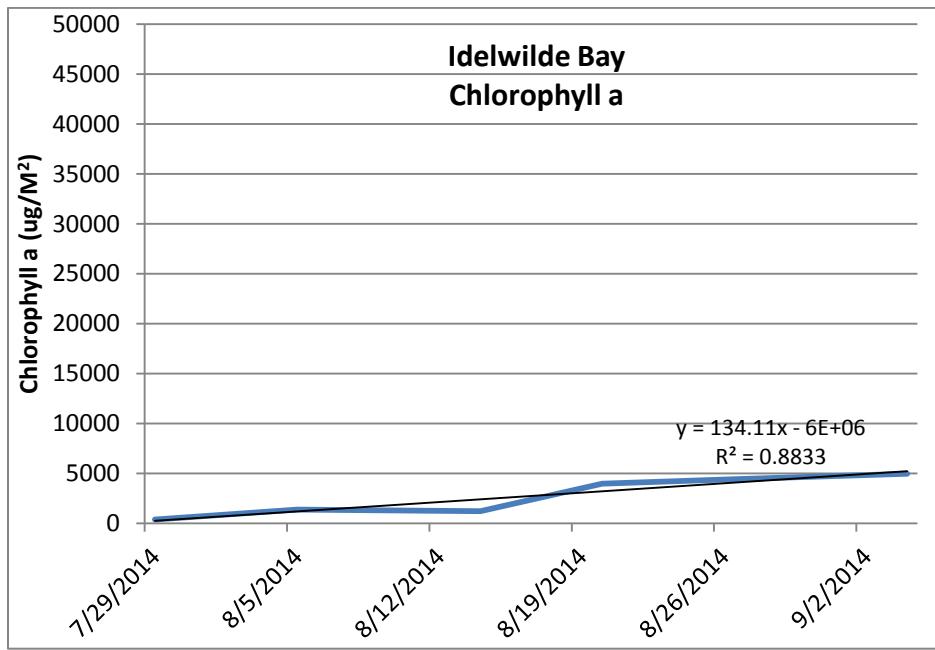
Figure 13. Periphyton chlorophyll-a growth rate, Idelwilde Bay, Lake Pend Oreille.

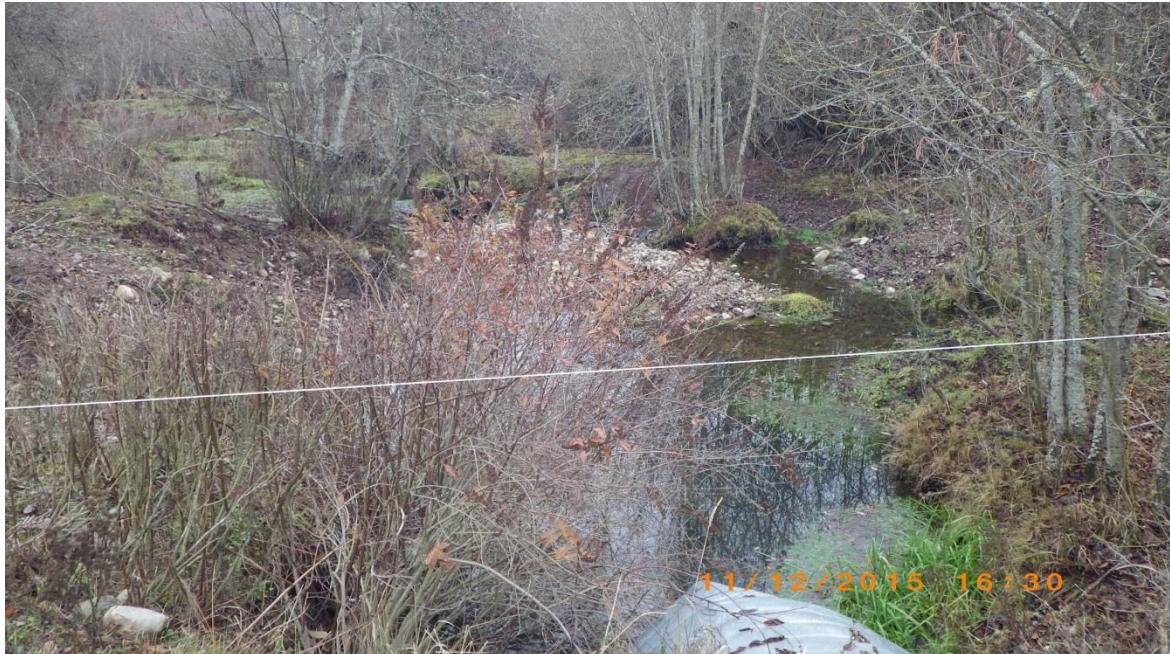
In 2015, DEQ conducted a survey of 12 stream crossing conditions within the Cocolalla Lake watershed (**Table 2**). Eight of the crossings had erosion issues. One crossing over Westmond Creek had severe erosion at the outlet of the culvert, which was exacerbated by cattle grazing (**Figure 14**). Three crossings had road fill erosion into the creek at the crossing (**Figure 15** and **Figure 16**). A bridge at the outlet of Cocolalla Lake was undersized with two overflow culverts that were rusted out (**Figure 17** and **Figure 18**).

Figure 14. Erosion at outlet of upper Cocolalla Creek crossing.

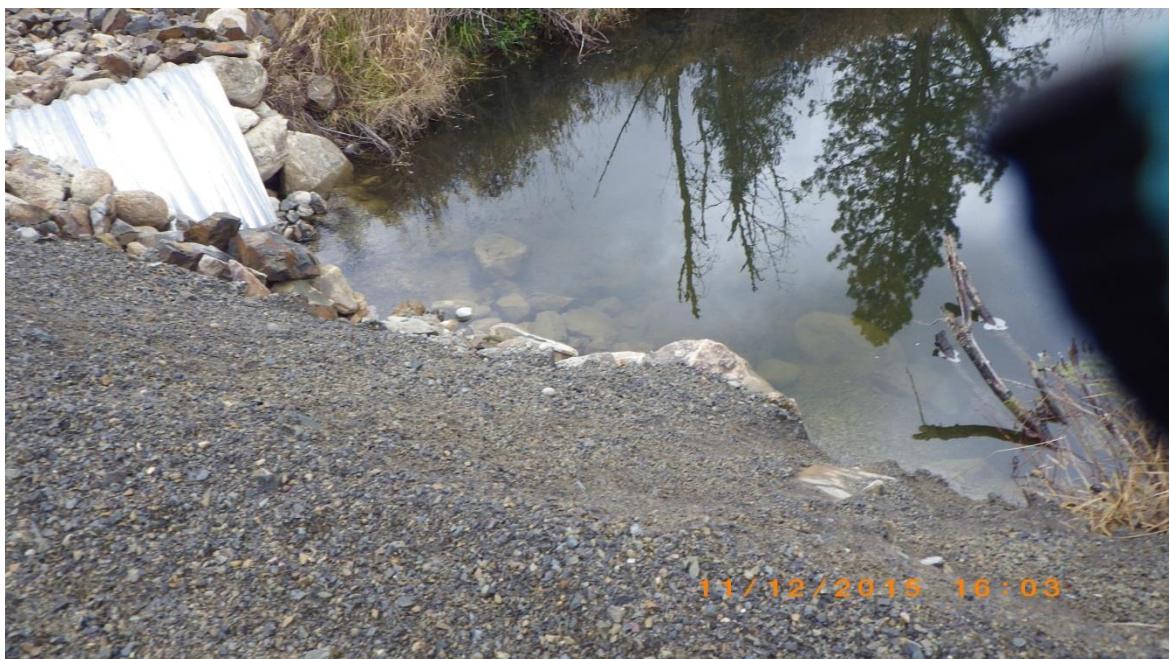
Figure 15. Road fill erosion into upper Cocolalla Creek.

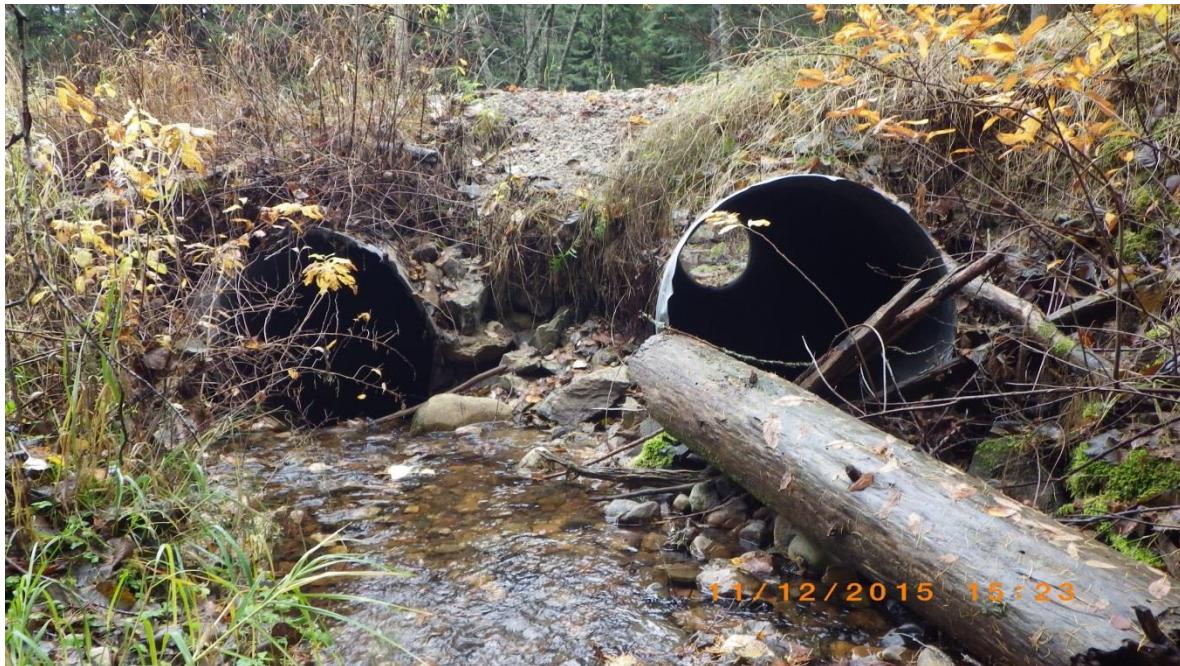
Figure 16. Road fill erosion into Fish Creek.

Reduce sediment in Fish Creek through road improvements and bank stabilization.

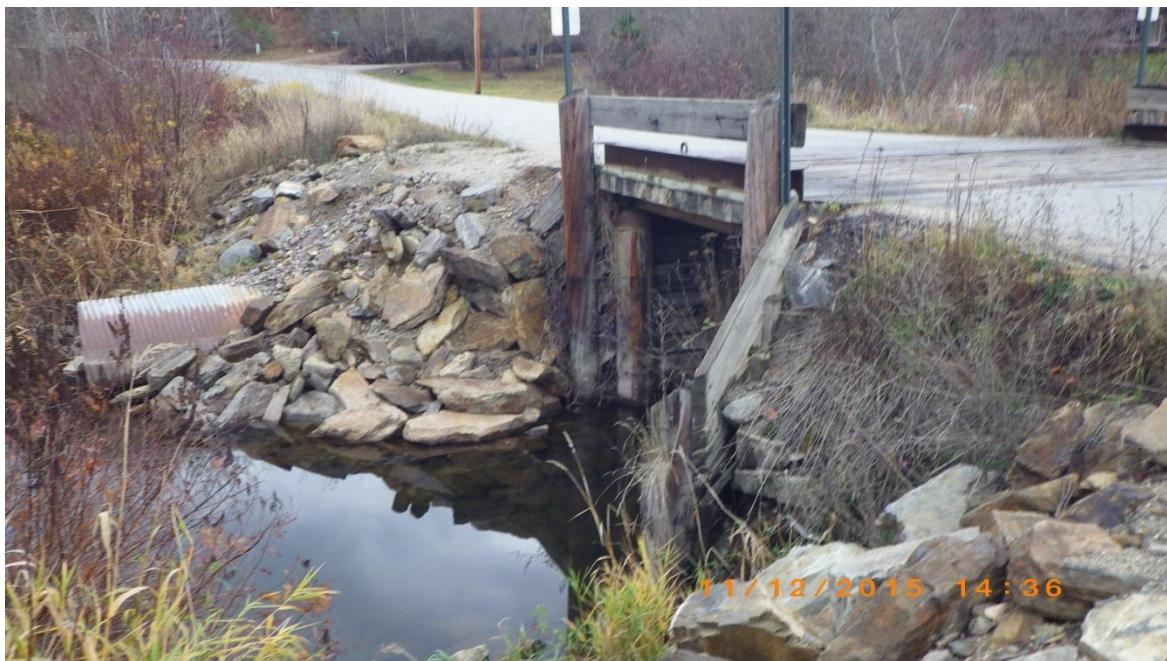
Figure 17. Undersized bridge at outlet of Cocolalla Lake.

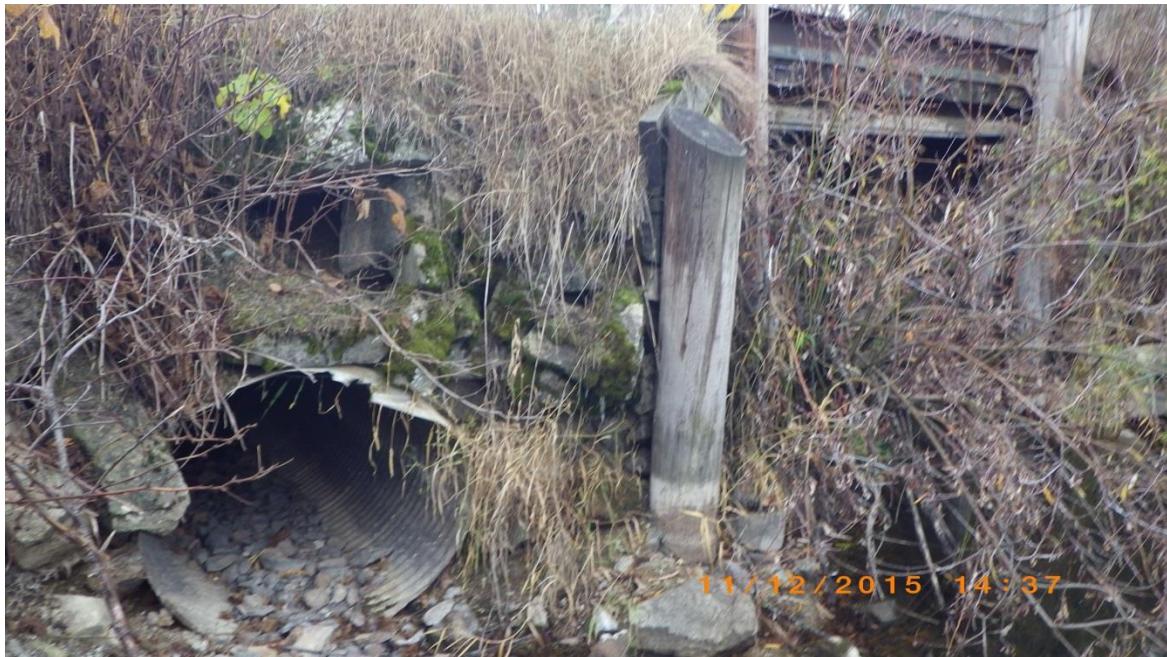
Figure 18. Rusted-out, overflow culvert at outlet of Cocolalla Lake.
